UNITED STATES ENVIRONMENTAL PROTECTION AGENCY
REGION 5
77 WEST JACKSON BOULEVARD
CHICAGO, IL 60604-3590

Re: Notice of Violation
Compliance Evaluation Inspection
INR000127159

Purpose of Inspection: This inspection was an evaluation of the Hawker Beechcraft Services, Incorporated's (HBS) compliance with hazardous waste, used oil, and universal waste regulations found at the Indiana Administrative Code (IAC) and the Code of Federal Regulations (CFR). I performed the inspection with Jessica Wilkes of the Indiana Department of Environmental Management (IDEM). The inspection was an EPA lead Resource Conservation and Recovery Act (RCRA) compliance evaluation inspection (CEI). The site notified as large quantity generator (LQG).

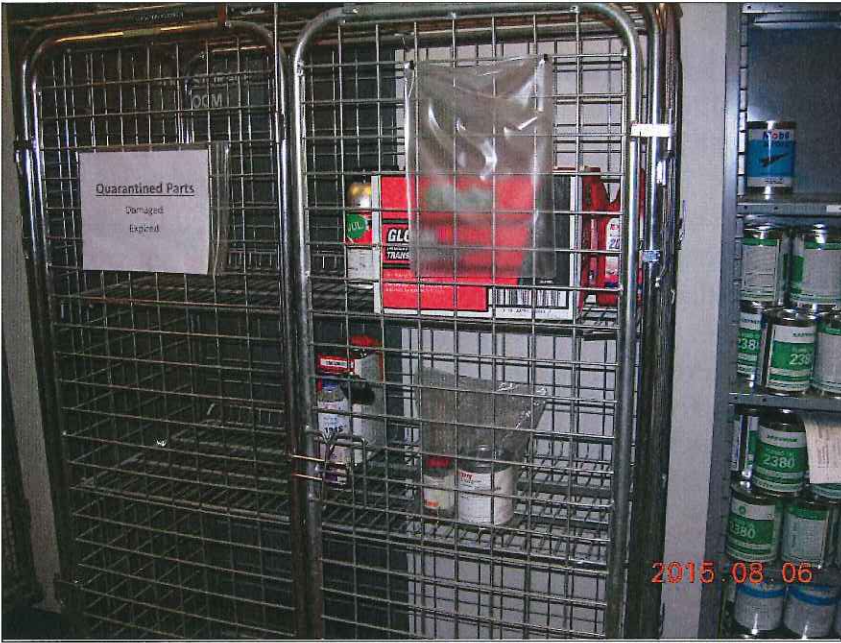
Picture #: 1 (DSCN 1268)
Date: August 6, 2015
Photographer: Dan Chachakis
Location: Parts Department
Subject: Cage for quarantined (i.e., waste) parts

Parts Department: I observed, and took a picture of, a cage in the Parts Department (Picture 1). Mr. Wilson stated that this container held expired product and other wastes; I recorded that this cage met the conditions for a satellite accumulation area.

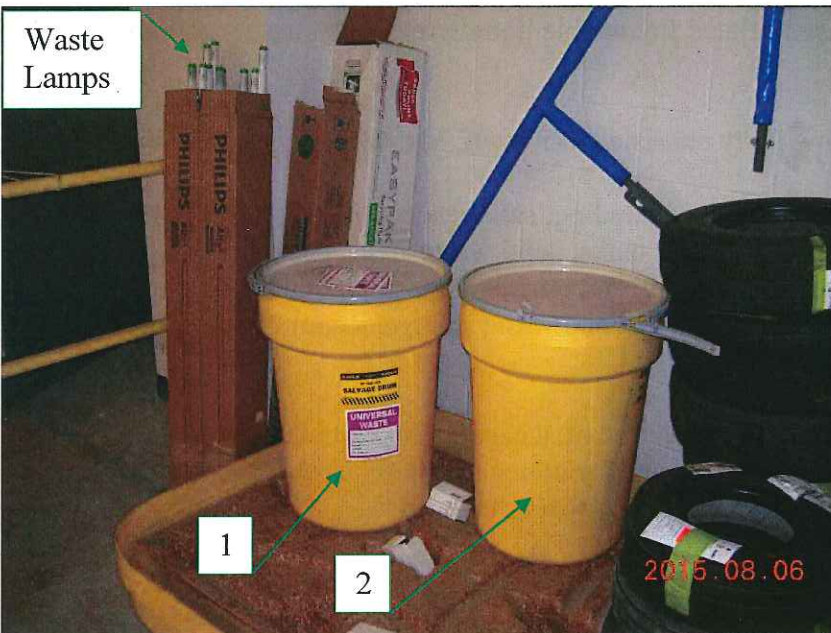
Picture #: 2 (DSCN 1269)
Date: August 6, 2015
Photographer: Dan Chachakis
Location: 2nd Floor
Subject: Universal waste containers

2nd Floor: I observed, and took a picture of, containers in the facility's universal waste storage area (Picture 2).

I recorded that container 1 in Picture 2 had a universal waste label, marked with words, "batteries" and the date, "11/2013." I moved the container and determined that the container held material.

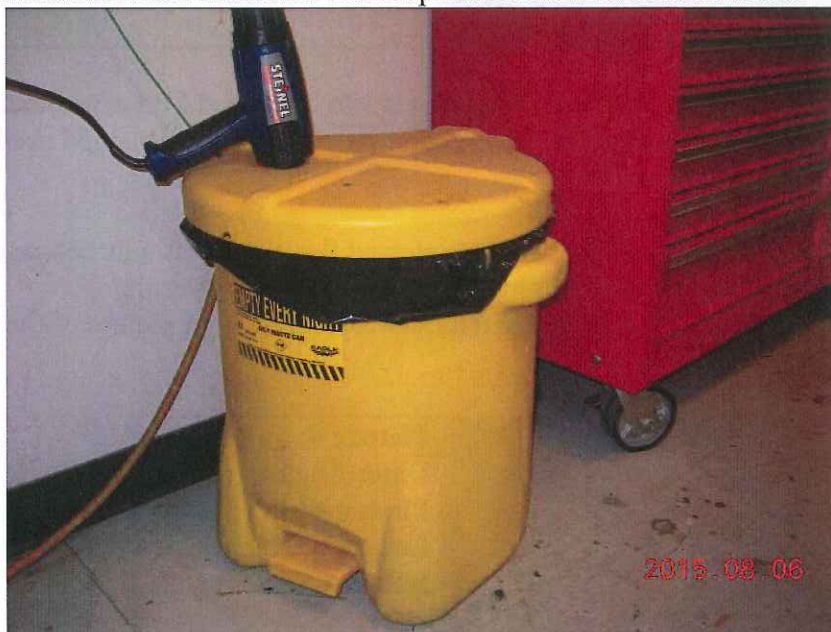
Picture #: 3 (DSCN 1270)
Date: August 6, 2015
Photographer: Dan Chachakis
Location: Upholstery
Department
Subject: Container of
hazardous waste

I observed, and took a picture of, a container with an, "Oily Waste Can" label (Picture 3). We opened the container and observed that the waste was not an oily waste. Mr. Wilson stated the material in the container was disposed of as a hazardous waste.

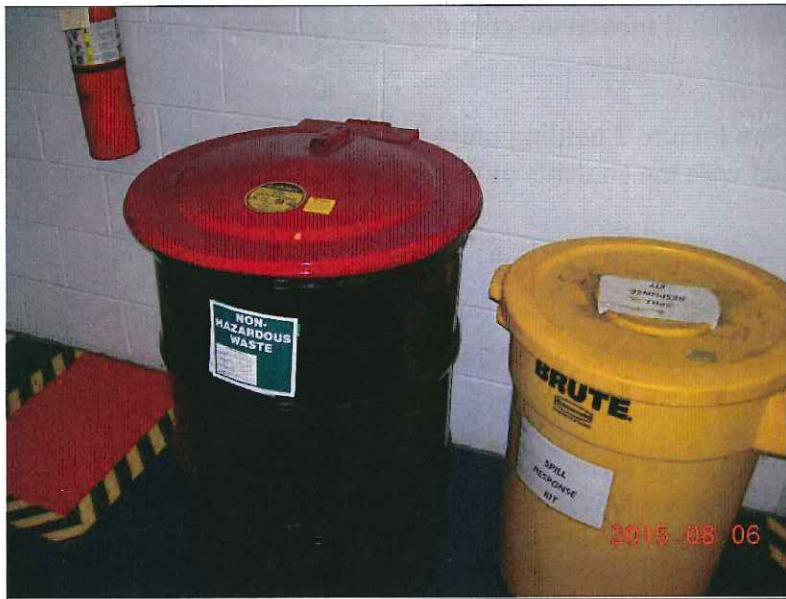
Picture #: 4 (DSCN 1271)
Date: August 6, 2015
Photographer: Dan Chachakis
Location: Hanger
Subject: Container of waste

Hanger: Mr. Davis joined us. I observed, and took a picture of, a spill response kit and a container with a non-hazardous waste label (Picture 4).

We opened the container in Picture 4 that had the non-hazardous waste label, and I observed that it held used spill pads; the container was close to full. Mr. Wilson stated the pads contained used fuel, oil and alcohol.

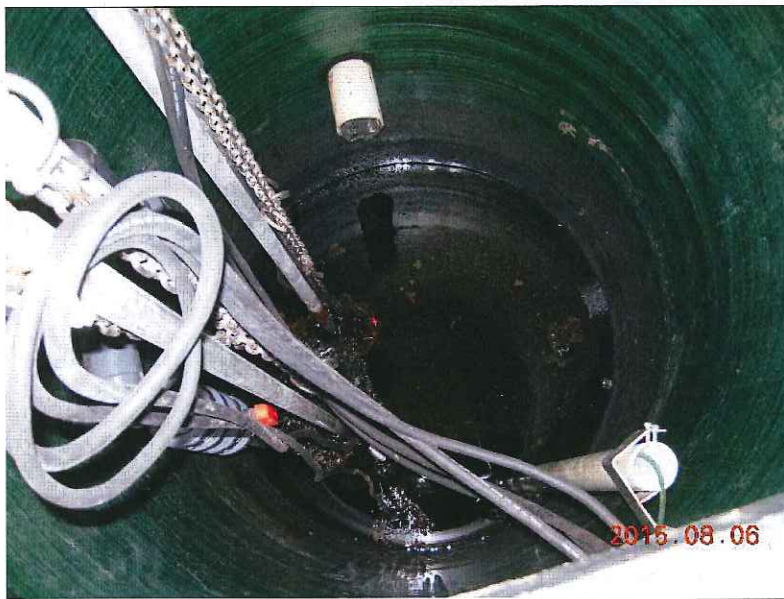
Picture #: 5 (DSCN 1272)
Date: August 6, 2015
Photographer: Dan Chachakis
Location: Hanger
Subject: Pit under the floor

I observed the presence of a cover in the floor. Mr. Wilson explained that there was a three-stage oil-water separator, part of the wastewater treatment system, and the cover was over the conveyance part of the system. I asked Mr. Wilson to open the cover, and I took a picture of the pit area under the cover (Picture 5).

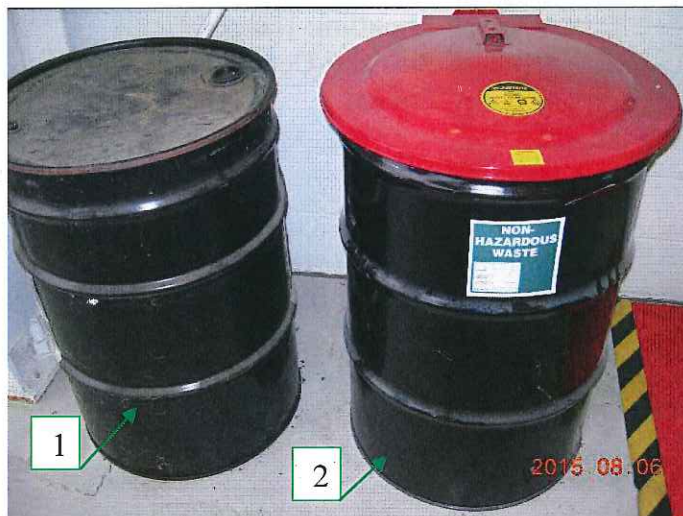
Picture #: 8 (DSCN 1275)
Date: August 6, 2015
Photographer: Dan Chachakis
Location: Hanger
Subject: Containers at Work Station 1

I observed, and took a picture of, the first two of four containers at the location Mr. Wilson described as Work Station 1 (Picture 8).

- Container 1 in Picture 8 was not marked or labeled. When we opened the container, we discovered the presence of empty oil cans.
- Container 2 in Picture 8 had a non-hazardous waste label and was marked with the words, "Used Spill Pads."

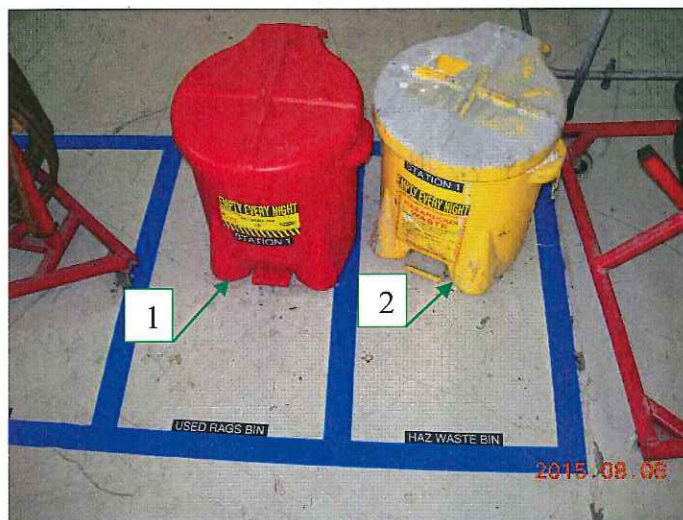
Picture #: 9 (DSCN 1276)
Date: August 6, 2015
Photographer: Dan Chachakis
Location: Hanger
Subject: Containers at Work Station 1

I observed, and took a picture of, the second two of four containers at the location Mr. Wilson described as Work Station 1 (Picture 9).

- Container 1 in Picture 9 was marked with the words, "Oily Waste Can."

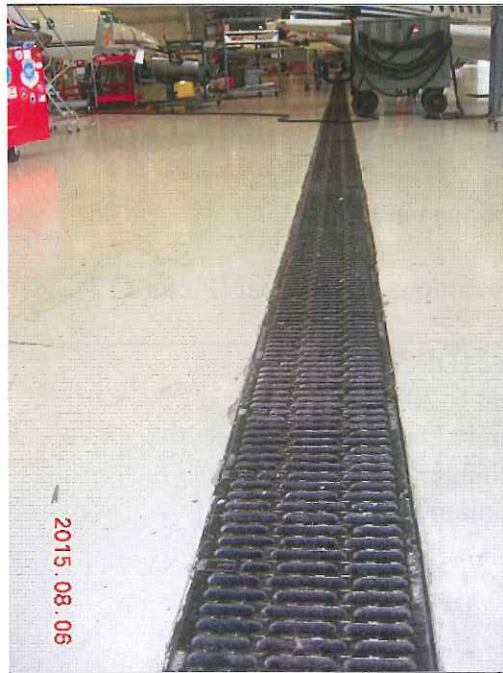
Picture #: 10 (DSCN 1277)
Date: August 6, 2015
Photographer: Dan Chachakis
Location: Hanger
Subject: Trench

I observed that the hanger floor was sloped and led to a series of trenches. I observed, and took a picture of, one of the trenches (Picture 10).

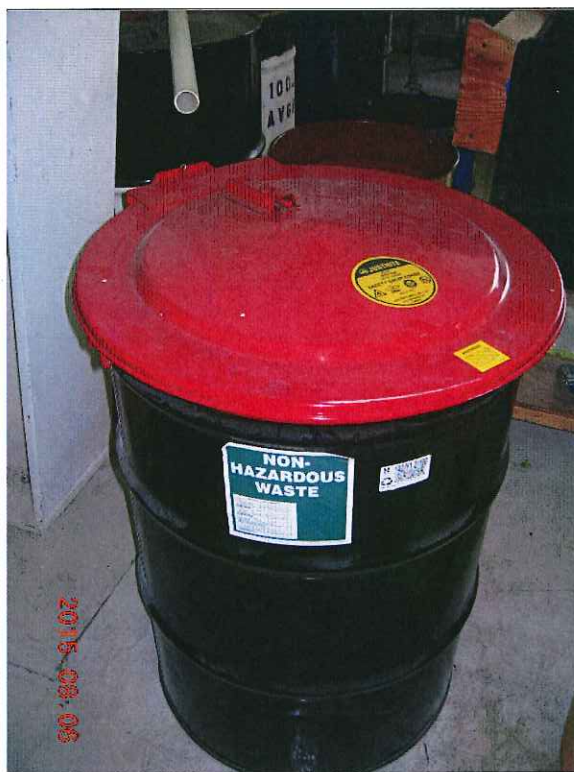
Picture #: 12 (DSCN 1279)
Date: August 6, 2015
Photographer: Dan Chachakis
Location: Hanger
Subject: Container

I observed, and took a picture of, a container with a non-hazardous waste label (Picture 12).

We opened the container, and I observed that it was almost full.

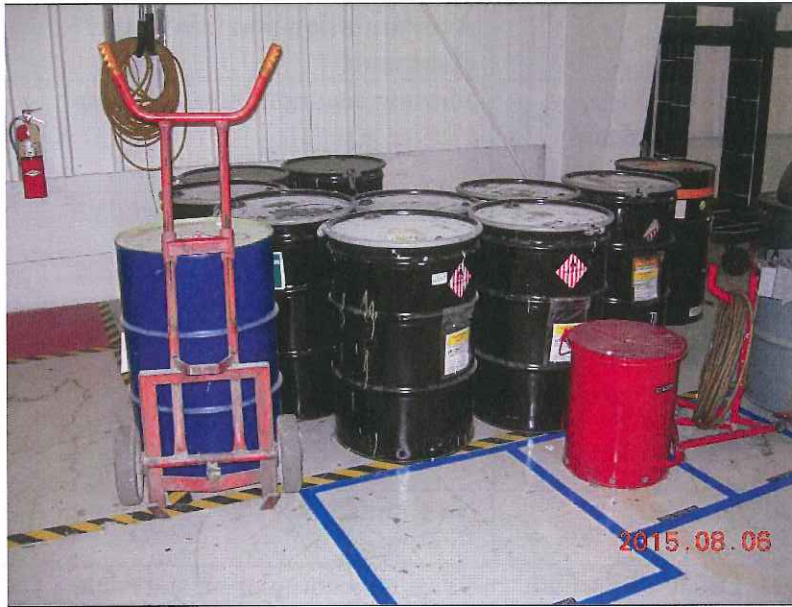
Picture #: 13 (DSCN 1280)
Date: August 6, 2015
Photographer: Dan Chachakis
Location: Hanger
Subject: Containers at Work Station 1

At the time of the inspection, HBS stored one 55-gallon drum container of Paint Waste D001 Ignitability / F005 Spent Solvent(s) hazardous waste in its Main Building less-than-90-day hazardous waste storage area with an accumulation date greater than 90 days, and was not granted an extension of the 90-day period (Picture 13).

At the time of the inspection, HBS stored seven 55-gallon containers in its Main Building less-than- 90-day hazardous waste storage area containing D001 Ignitability and other characteristic hazardous wastes that were not marked with the date upon which each period of accumulation of hazardous waste began, and one additional container was marked with an incomplete date of, "2-5" (Picture 13).

We moved to the less-than 90-day hazardous waste storage area within the hanger; I observed, and took a picture of, this area (Picture 13).

I diagramed, and recorded information from, the containers in this area (Diagram 1 of the containers in Picture 13).

| # | Label Type | Markings | Accumulation start date and comments |
|---|---|--|---|
| 1 | Hazardous Waste Label | D001, F005, D035, Waste Paint Related Material | Missing accumulation start date |

At the time of the inspection, HBS was using a two-number date system marked in the accumulation start date line of the hazardous waste labels. This is an incomplete accumulation start date. The accumulation start date must indicate the month, day and year accumulation begins.

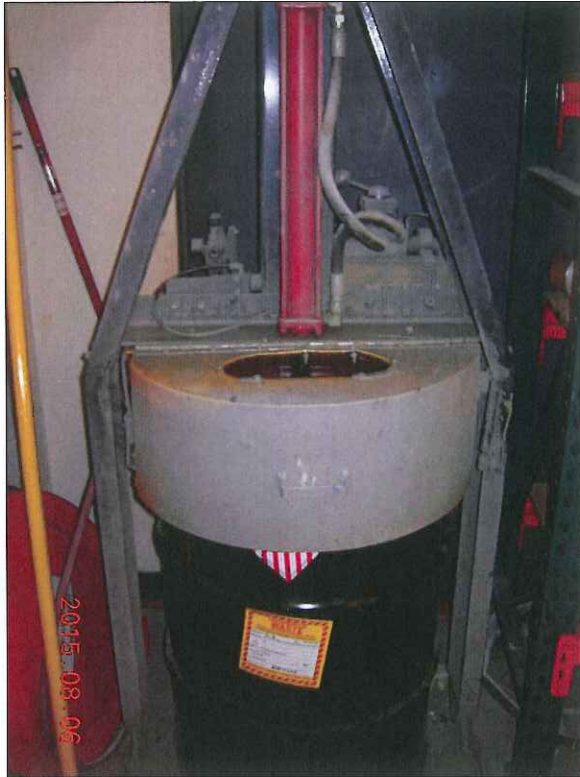
Picture #: 14 (DSCN 1281)

At the time of the inspection, HBS stored one 55-gallon satellite container of D001 Ignitability hazardous waste in the Main Building Riser Room at the machine used to crush the contents of the container (Picture 14), rather than at the point of generation.

Riser Room: I observed, and took a picture of, a container with a hazardous waste label inside a compressor unit (Picture 14).

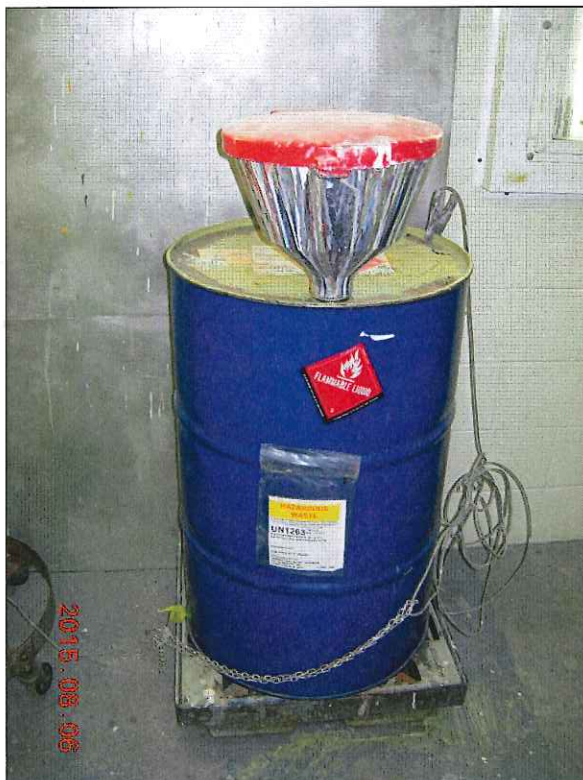
Picture #: 15 (DSCN 1282)
Date: August 6, 2015
Photographer: Dan Chachakis
Location: Paint Booth
Subject: Container

Paint Booth: I observed that the Paint Booth was large enough to hold a complete, intact airplane. I observed, and took a picture of, a container with a hazardous waste label (Picture 15).

I recorded that the container in Picture 15 had a hazardous waste label, and was marked with the words, "Waste Paint Related Materials" and "D001, F005."

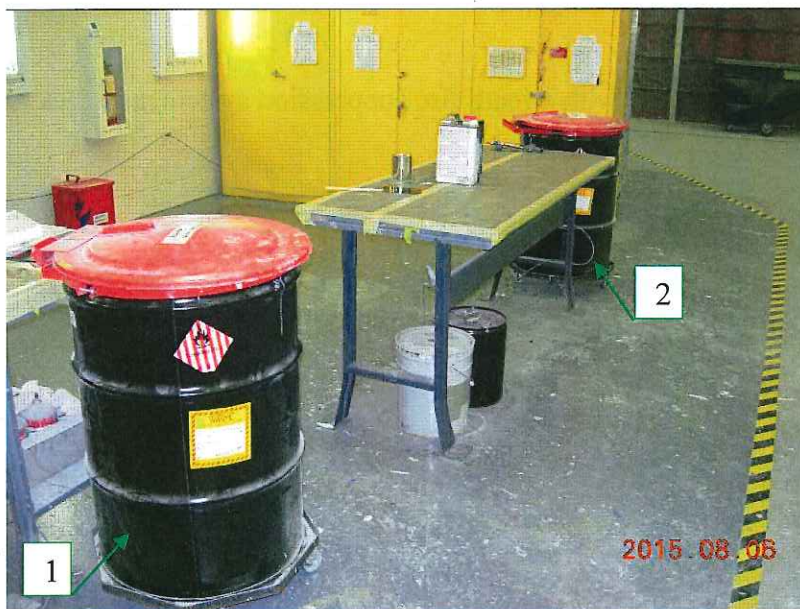
Picture #: 16 (DSCN 1283)
Date: August 6, 2015
Photographer: Dan Chachakis
Location: Hanger
Subject: Containers

At the time of the inspection, at two separate satellite accumulation areas in the Main Building Hangar, HBS stored two 55-gallon satellite containers (one at each satellite container area) holding D001 Ignitability hazardous waste that had incorrect descriptions of the actual contents of the container (i.e., HBS used the wrong description to identify the contents of the containers) (Picture 16).

I observed, and took a picture of, two containers that Mr. Wilson stated were satellite containers of hazardous waste (Picture 16).

I recorded that Container 1 in Picture 16 was marked with the words, "Chromium" and "D007, F005"; and the accumulation start date of "1-5."

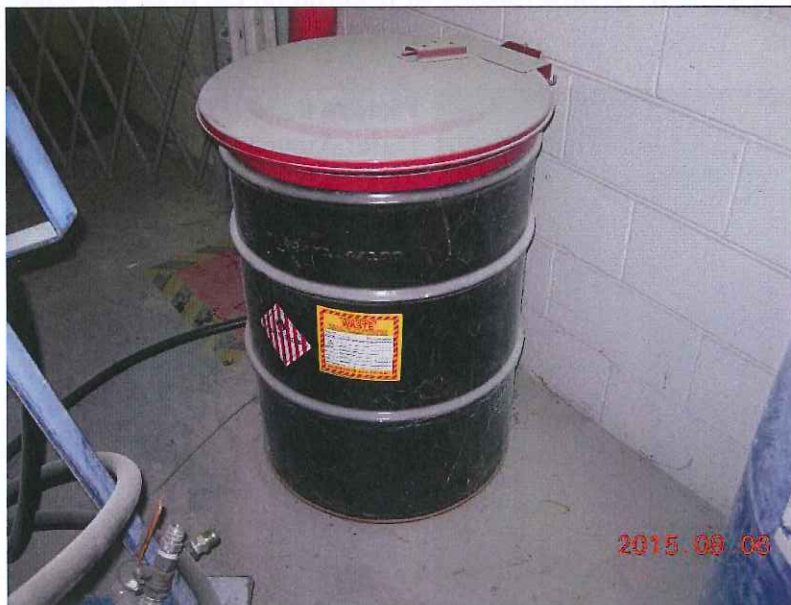
Picture #: 17 (DSCN 1284)
Date: August 6, 2015
Photographer: Dan Chachakis
Location: Building 137 Hanger
Subject: Container

I recorded that the container in Picture 17 had a hazardous waste label and was marked with the words, "MEK" and "D001, D035, F005."

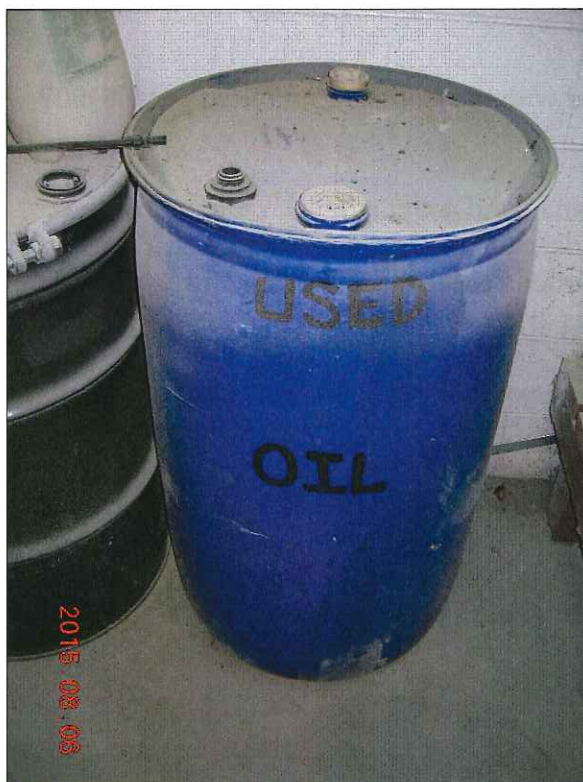
Picture #: 18 (DSCN 1285)
Date: August 6, 2015
Photographer: Dan Chachakis
Location: Building 137 Hanger
Subject: Container

I observed, and took a picture of, a container marked with the words, "Used Oil" (Picture 18).

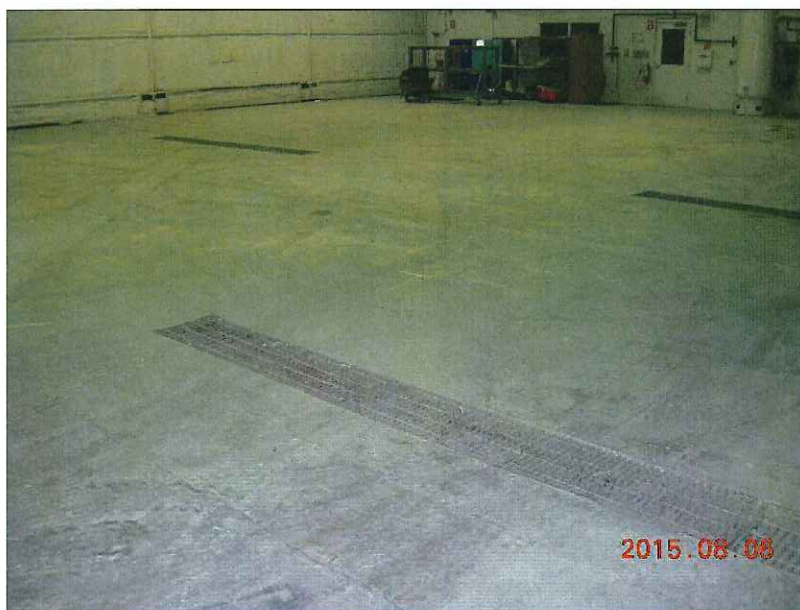
Picture #: 19 (DSCN 1286)
Date: August 6, 2015
Photographer: Dan Chachakis
Location: Building 137 Hanger
Subject: Trench

At the time of the inspection, HBS had dust from D007 Chromium hazardous waste or its constituents on the floor of Hangar Building 137 (Pictures 19, 24, and 29).

I observed, and took a picture of, a hazardous waste system that included trenches (Picture 19), and totes (Picture 20). I also observed a green / yellow dusting of material on the floor in Picture 19.

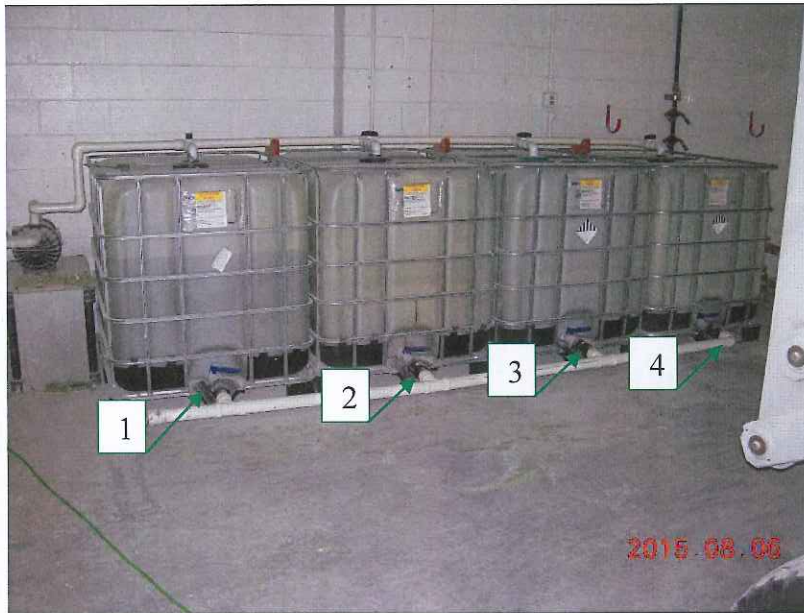
Picture #: 20 (DSCN 1287)
Date: August 6, 2015
Photographer: Dan Chachakis
Location: Building 137 Hanger
Subject: Totes

At the time of the inspection, HBS stored a tote in Hangar Building 137 containing D007 Chromium hazardous waste holding over 55 gallons of hazardous waste that was not marked with the date upon which the period of accumulation of hazardous waste began (Pictures 20, 21 and 23).

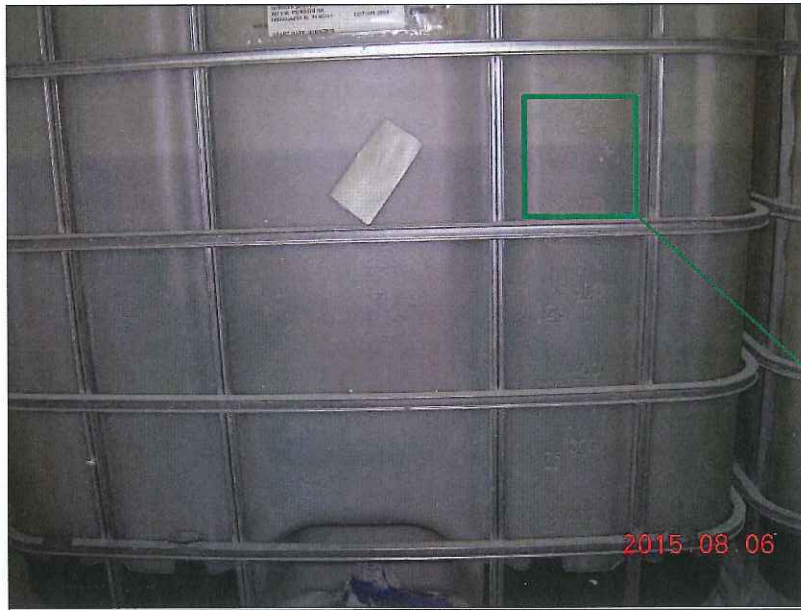
Picture #: 21 (DSCN 1288)
Date: August 6, 2015
Photographer: Dan Chachakis
Location: Building 137 Hanger
Subject: Tote 1

I observed, and took a picture of, the line in tote 1 in Picture 17 showing over 175 gallons of material. The hazardous waste label on tote 1 was not marked with an accumulation start date (Picture 18).

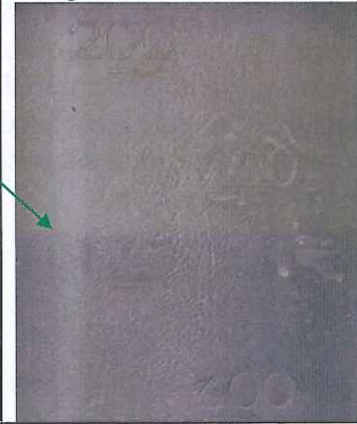
I observed, and took a picture of, a pit that was part of the trench to the tote system, and the material within the pit (Picture 22).

Mr. Price stated the pit was 4' x 4' x 4', with approximately 3" of material remaining in the pit after it was last pumped out. I calculated that 4' = 56"; 56" x 56" x 3" = 9,408 cubic inches. I found through research that 1 cubic inch = 0.004329 U.S. gallons. I calculated that 9,408 cubic inches x 0.004329 = 40.72 gallons. Therefore, there was approximately 40 gallons of hazardous waste within the pit at the time of the inspection. Mr. Price stated that the pit was never, "completely empty" and that the amount of material within the pit at the time of the inspection was normal. I observed that there was no hazardous waste markings or labels associated with the trenches, pit or the lines leading to and away from the totes. I observed that there was no overflow warning or prevention device associated with the pit. I observed that there was no accumulation start date associated with the pit. Mr. Wilson stated that there were no written inspection records for the pit, and he was unable to provide an accumulation start date record for the material in the pit.

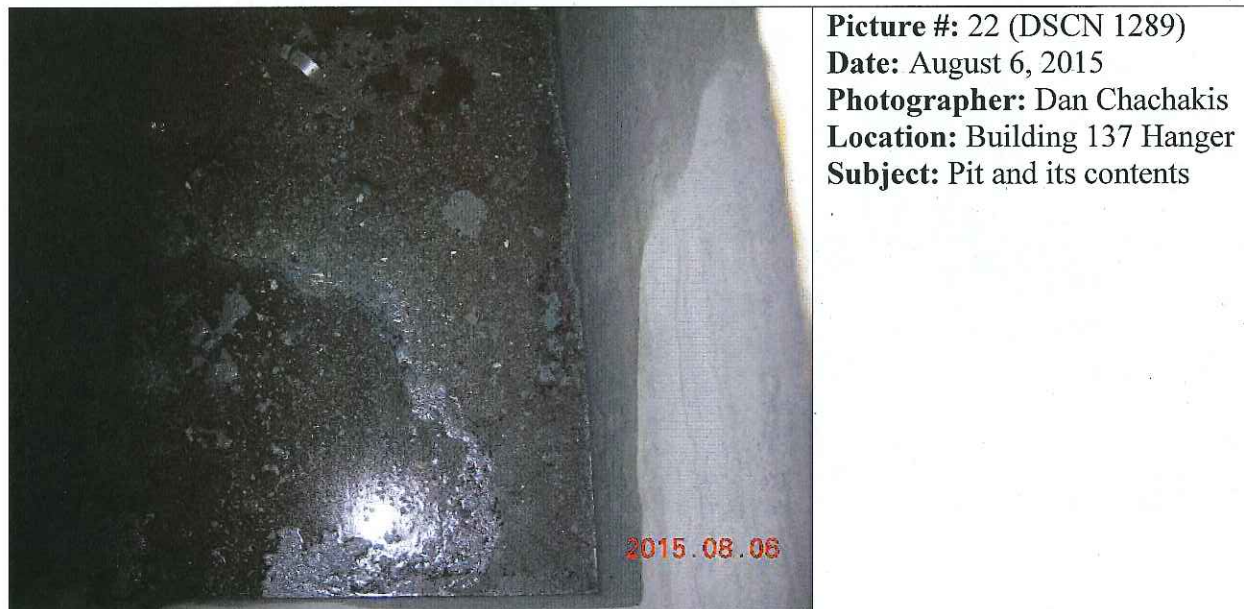
At the time of the inspection, HBS did not have a written hazardous waste tank assessment for its pit in Hangar Building 137 that was being used as a hazardous waste tank containing D007 hazardous waste (Pictures 22 and 23).

At the time of the inspection, HBS used a pit in Hangar Building 137 as a hazardous waste storage tank containing over 40 gallons of D007 Chromium hazardous waste that was not marked with the date upon which the period of accumulation of hazardous waste began (Pictures 22 and 23).

At the time of the inspection, HBS used a pit in Hangar Building 137 as a hazardous waste storage tank containing over 40 gallons of D007 Chromium hazardous waste that was not marked or labeled with the words, "Hazardous Waste" at or near the tank (Pictures 22 and 23).

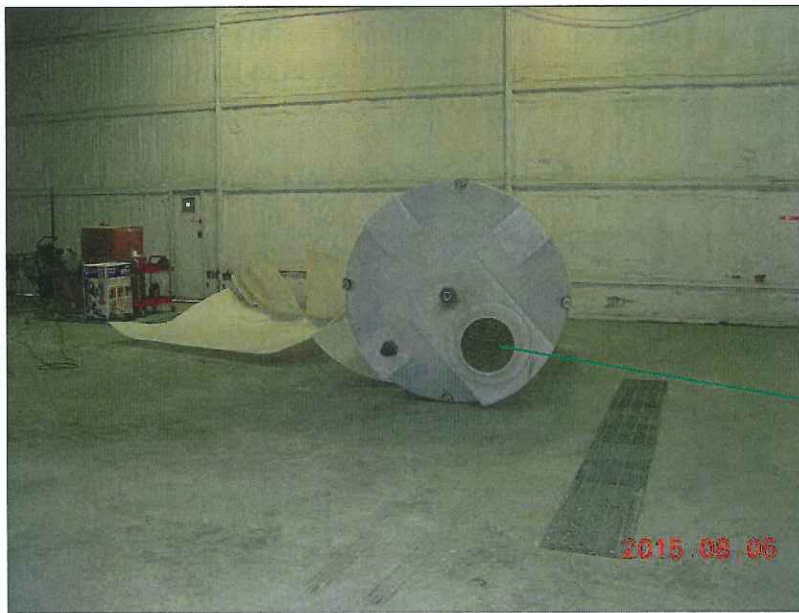
Picture #: 24 (DSCN 1291)
Date: August 6, 2015
Photographer: Dan Chachakis
Location: Building 137 Hanger
Subject: Tank out of service

At the time of the inspection, HBS was dismantling a hazardous waste storage tank in Hangar Building 137 (Picture 24). This tank was open, and the inside was still coated with D007 Chromium hazardous waste.

I observed, and took a picture of, a tank that Mr. Price described as an out of service hazardous waste storage tank (Picture 24). I noted the material still within the tank.

Mr. Wilson stated that the facility did not inform IDEM of the tank closure. Ms. Wilkes confirmed that IDEM did not know of the tank closure activity.

HBS is removing a hazardous waste storage tank without notifying IDEM. EPA recommends that HBS notify IDEM about the closure of the hazardous waste storage tank.

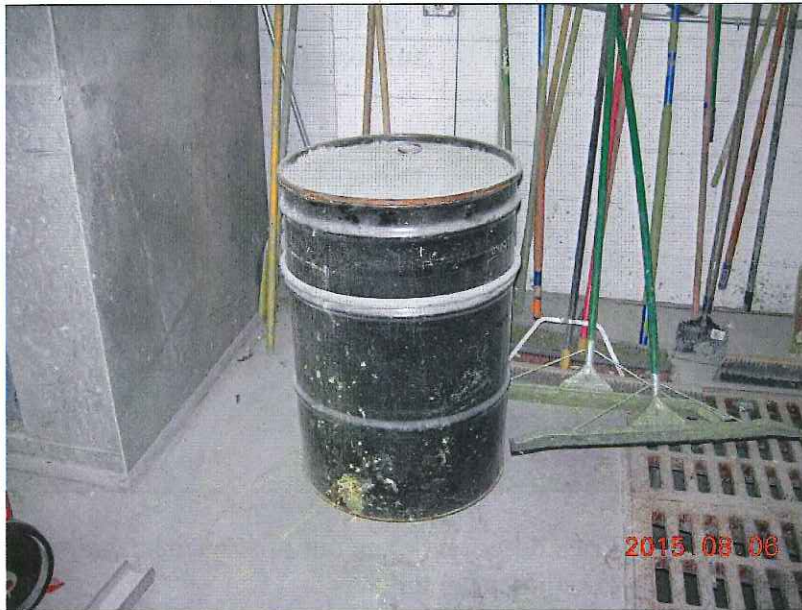
Picture #: 25 (DSCN 1292)
Date: August 6, 2015
Photographer: Dan Chachakis
Location: Building 137 Hanger
Subject: Container

At the time of the inspection, HBS stored one 55-gallon container in Hangar Building 137 containing D007 Chromium hazardous waste that was not marked or labeled with the words, "Hazardous Waste" (Picture 25).

I observed, and took a picture of, a container that did not have a label or marking describing its contents (Picture 25).

We opened the container in Picture 25, and observed that the container was approximately 1/3rd full of what appeared to be paint chips. Mr. Wilson stated that the material in the container is normally handled by the facility as hazardous waste.

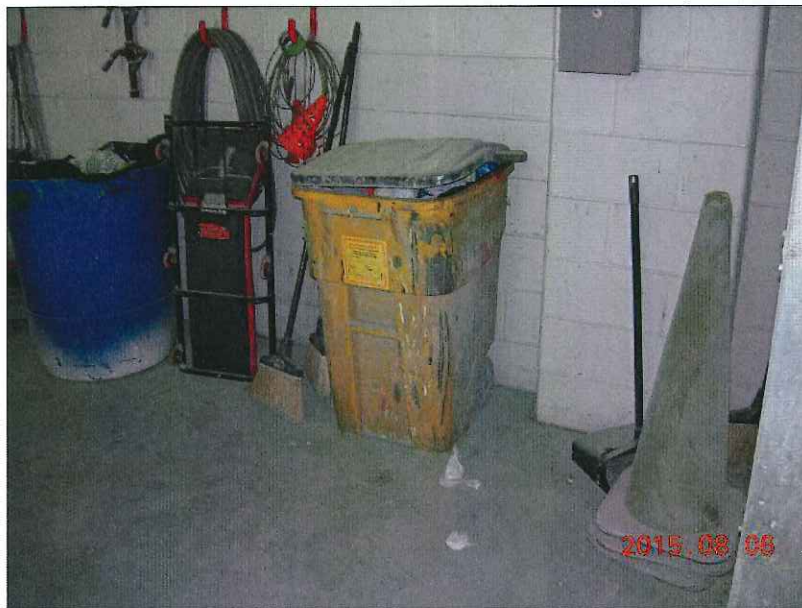
Picture #: 26 (DSCN 1293)
Date: August 6, 2015
Photographer: Dan Chachakis
Location: Building 137 Hanger
Subject: Container

At the time of the inspection, HBS stored one yellow 55-gallon satellite container with a hazardous waste label holding D001 Ignitability hazardous waste in Hangar Building 137 that was overfull without the date the excess amount began accumulating marked on the container (Picture 26).

At the time of the inspection, HBS stored one black 55-gallon satellite container with a hazardous waste label and the words, "Paint Chips", holding D001 Ignitability hazardous waste in Hangar Building 137 that was overfull without the date the excess amount began accumulating marked on the container (Pictures 26 and 27).

I observed, and took a picture of, a container with a hazardous waste label (Picture 26).

I observed that the container in Picture 26 was overfull and could not close properly.

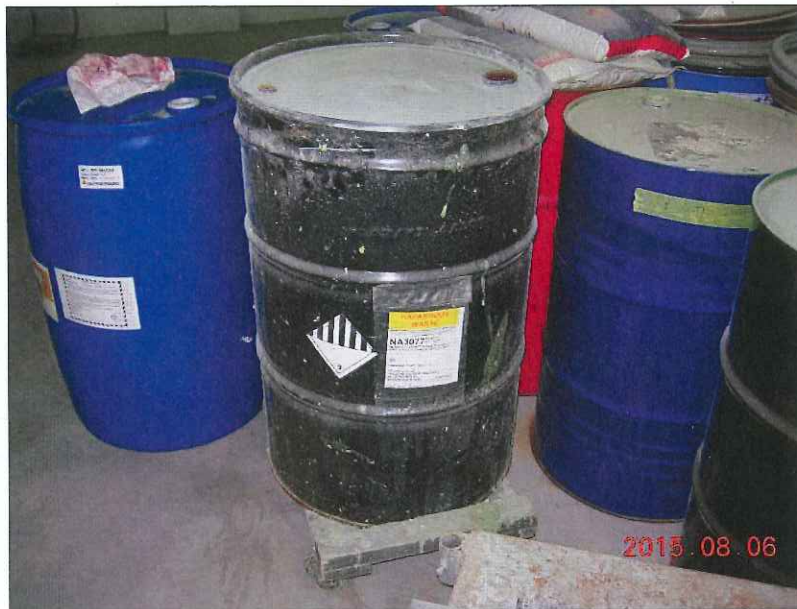
Picture #: 27 (DSCN 1294)
Date: August 6, 2015
Photographer: Dan Chachakis
Location: Building 137 Hanger
Subject: Container

At the time of the inspection, HBS had a container of hazardous waste in Hangar Building 137 that was purposely not closed in order to allow venting into the air because the container, according to facility representatives, had the potential to generate gas and explode if closed (Picture 27), without any indication (label or markings on the container) that the material in the container had an explosive potential. *[Note: The label on the container in question was marked with the words "Hazardous Waste, Solid, N.O.S., 9, PGIII (Chromium), (D007)", and did not indicate that there was any material in the container that would lead to an explosion. Please provide in your response to this NOV: 1) an explanation of the explosive potential of the material in the container, 2) An average volatile organic (VO) concentration determination conducted in accordance with 40 CFR 265.1084 for the material in the container, and 3) a determination of whether or not the volatile emission(s) could be captured with an appropriate filter system.]*

I observed, and took a picture of, a container with a hazardous waste label marked with the words, "Paint Chips" (Picture 27).

I observed that the container in Picture 27 was not closed. Mr. Wilson stated the container could not be closed because of the materials had the potential to generate gas and explode.

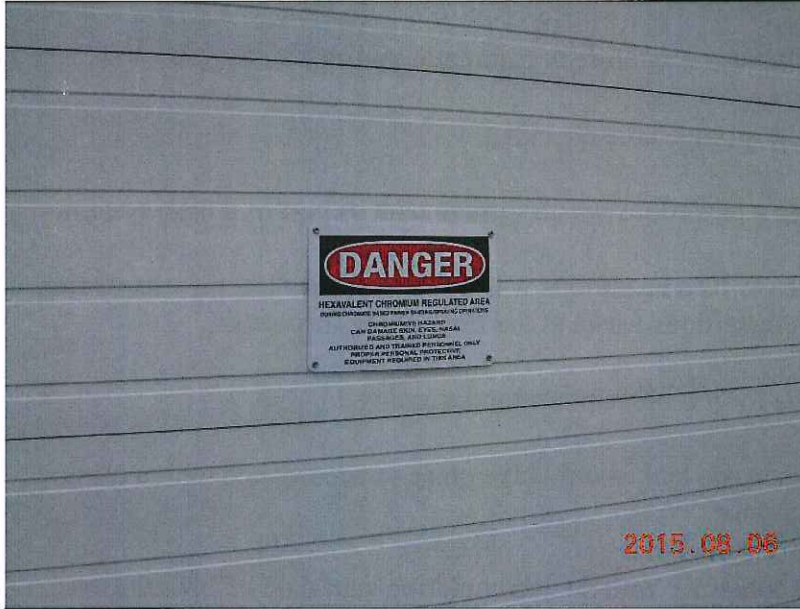
Picture #: 28 (DSCN 1296)
Date: August 6, 2015
Photographer: Dan Chachakis
Location: Building 137 Hanger
Subject: Warning Sign

Building 137: I observed, and took a picture of, a warning sign (Picture 28).

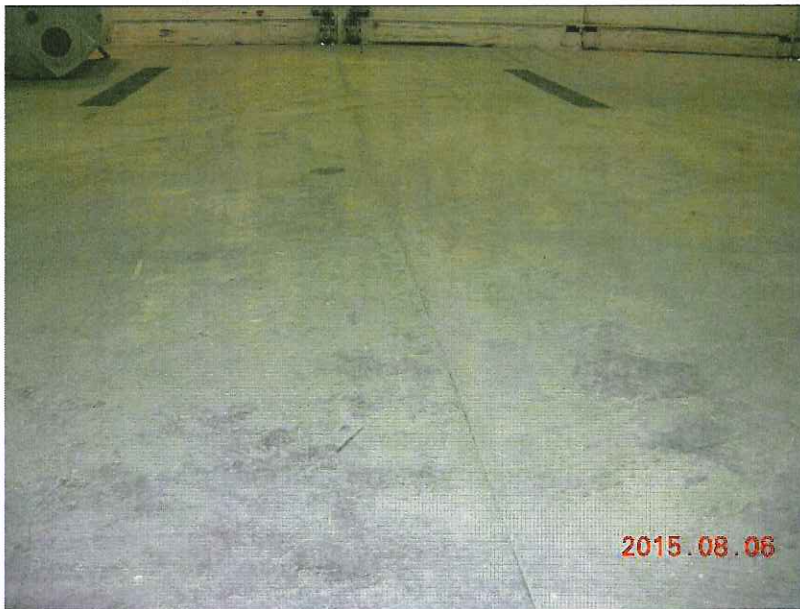
Picture #: 29 (DSCN 1296)
Date: August 6, 2015
Photographer: Dan Chachakis
Location: Building 137 Hanger
Subject: Yellow / Green material

I observed, and took a picture of, the yellow / green material on the floor of the hanger (Picture 29).
